Low Flow Inventory

Summary

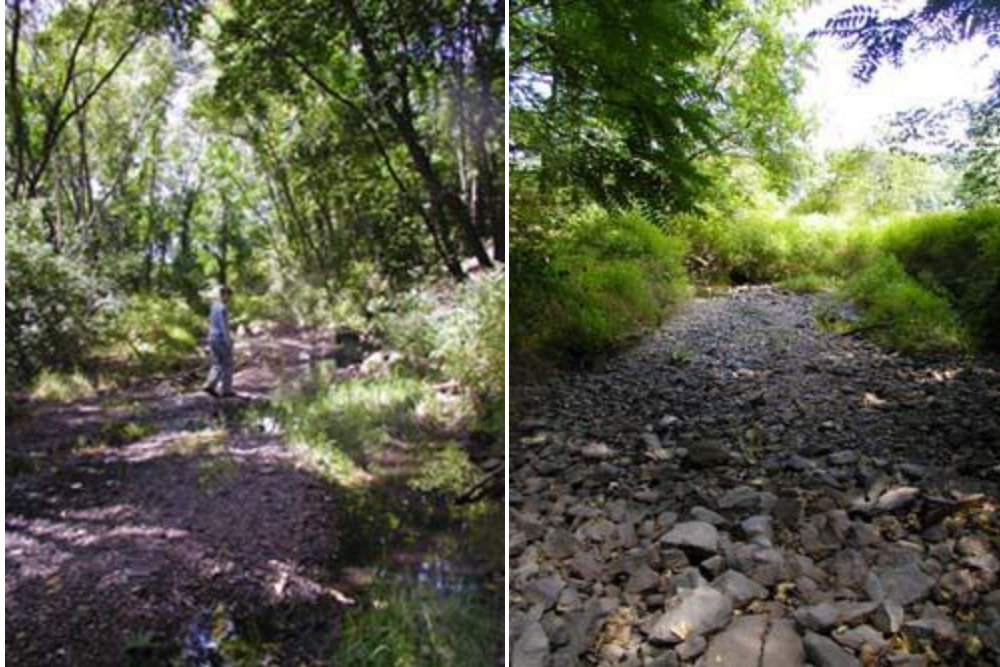
Poor Farm Brook between City Farm Pond and Lake Quinsigamond, Shrewsbury, was dry on September 2, 2004.

- Streamside wells in the Town of Auburn may affect water levels in Dark Brook.
- The Town of Shrewsbury's well field near Poor Farm Brook may have exacerbated the low water levels that resulted in the brook drying up from City Farm Pond to Lake Quinsigamond in 1998.
- Mill River and Peters River also had low flows which may be the result of nearby groundwater withdrawals.
- In 2004, a DEP staff member observed Purgatory Brook in Sutton dry below Swans Pond with stagnant, non-flowing conditions upstream to the reservoir. Private irrigation wells and development are the suspected causes of declining streamflows in Purgatory Brook. (17)

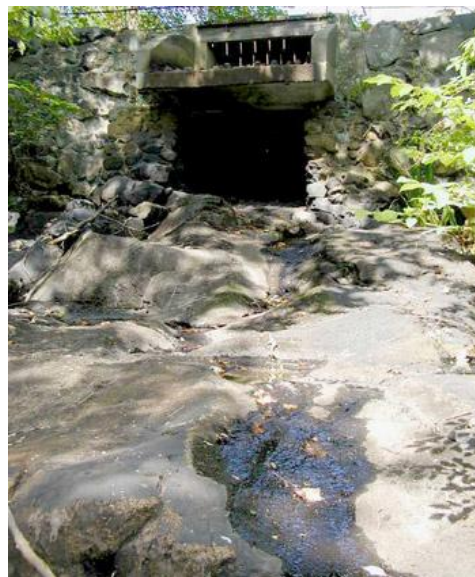
Beaver Brook Reservation on the Belmont/Waltham town line has several water control structures that maintain water levels in Mill Pond and Duck Pond. DEP staff observed that the Beaver Brook streambed was dry from Duck Pond to the lower end of the Reservation during 1995 due to water level management at Duck Pond outlet. This stretch of the Brook has “superb” fish and macroinvertebrate habitat features, but has a moderately impaired benthic macroinvertebrate community because of flow disruptions like the one observed in 1995 (1). The photo here shows the dam at Duck Pond, looking upstream, with no water passing over the spillway on August 15, 2002. A small amount of water can be seen in the photo seeping through the base of the dam, creating the trickle down the streambed.

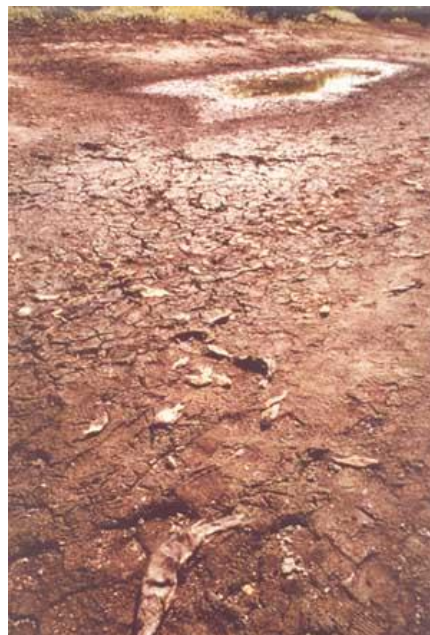
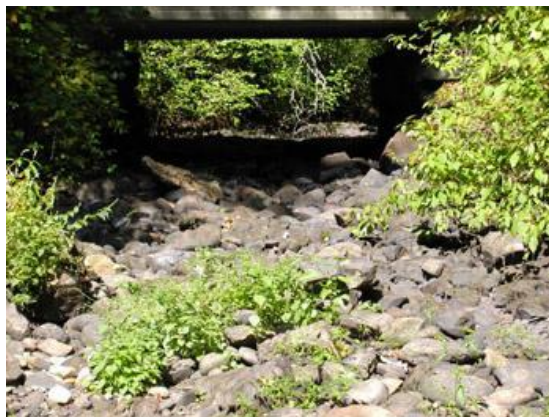
One resident reports that Fish Brook in Boxford has dried completely for the last several years and now dries up for a longer period each summer. This photo shows the Fish Brook dry streambed at Brookview Road in Boxford on September 17, 2002 (17).

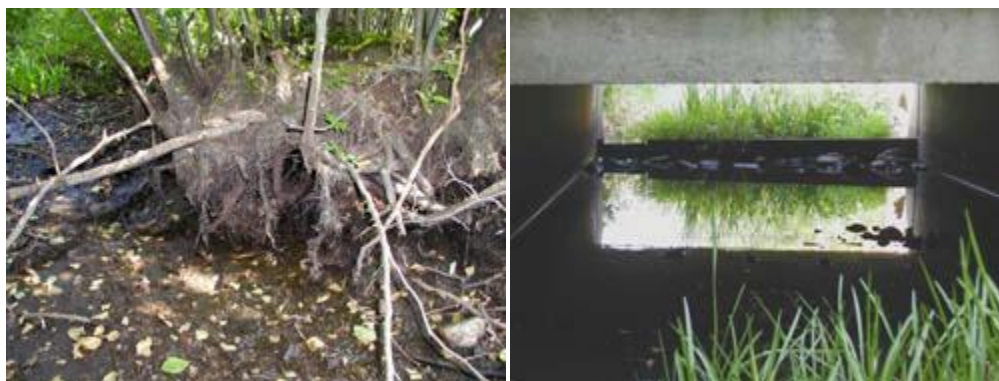
DEP staff observed stagnant water and no flow to the unnamed tributary below the outlet of Babson Reservoir in Gloucester (1,2). This section is downstream of the public water supply intake at Babson Reservoir as well as Alewife Brook, where low flows were also observed (see *Consequences: Aquatic Flora and Fauna*). Below are photos of the nearly dry streambed in Alewife Brook at Pond Street in Essex (left) and the flashboard under Apple St. in Essex with no water flowing over it (right, looking upstream) taken on August 15, 2002.

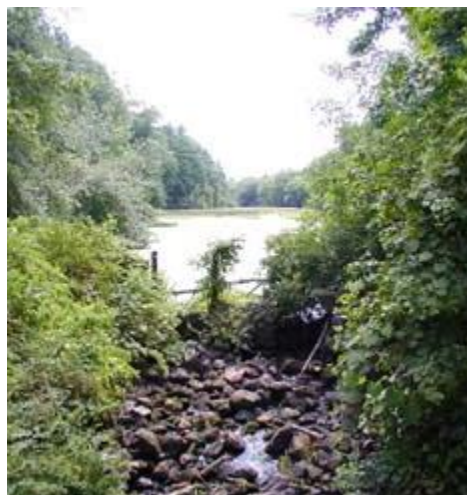
The Mill River (right) in Boxford and Rowley was observed by DEP staff with only 50% of its channel inundated in summer of 1999. The other 50% of the channel was unavailable as habitat for fish and other aquatic organisms. The Water Quality Assessment Report also noted inadequate fish passage in the Mill River (3).

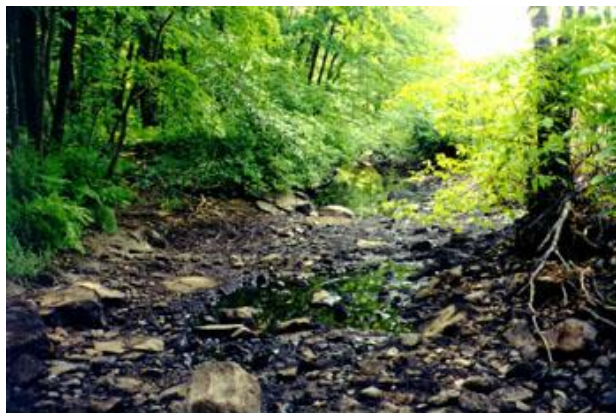
The Organization for the Assabet River (OAR) is concerned that the operation of the Howard Street wells in Northborough is depleting stream flow in Howard Brook and possibly impacting the trout fishery there (6). A vernal pool site near a well field in Acton was also nearly dry in early spring of 2002, a time when this pool has been about five feet deep in the past (4).

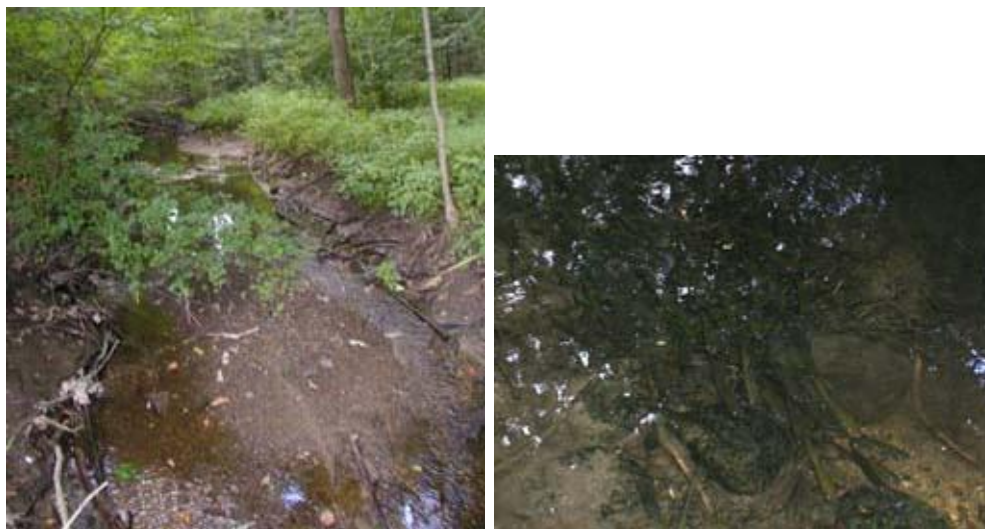
Jackstraw Brook in Westborough was observed dry between Westborough's water supply wells on August 12, 2004. Several isolated pools near Upton Road were the last refuge for native brook trout (see photo below), whose presence indicates that this brook was once a high quality cold water fishery. Low

flows and heavy sediment loads from upstream development have degraded habitat for aquatic species, and the trout have to congregate in the few remaining pools for survival (11).

Low flows and heavy sediment loads from upstream development degrade habitat for coldwater fisheries in Jackstraw Brook, Westborough (left). Native brook trout survive in isolated pools along Jackstraw Brook (right). September 2, 2004.

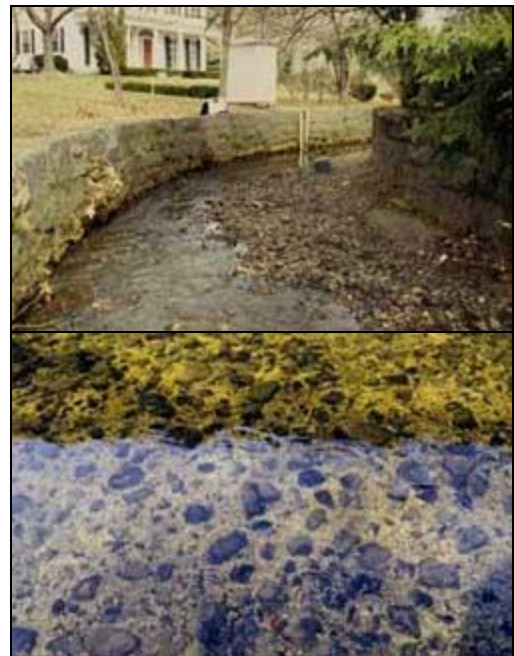
A unique bypass problem occurs as a result of the US Army Corps of Engineers' "deep rock tunnel" from Town Brook in Quincy to the Atlantic Ocean (top photo, March 1998). The tunnel was created to alleviate flooding problems downstream, but also siphons away baseflows, causing chronic low flows over smelt-spawning habitat. These conditions have resulted in significant smelt egg kills and spawning habitat degradation over the last five years (bottom photo, March 1998).

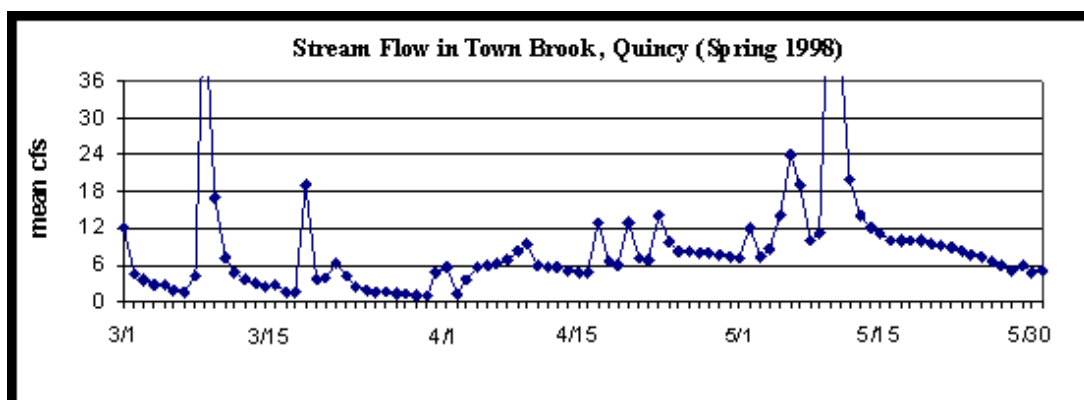
In addition to the dewatering caused by the deep rock tunnel, Town Brook also experiences frequent streamflow spikes, which cause additional stress to the aquatic community (4) (see hydrograph below).

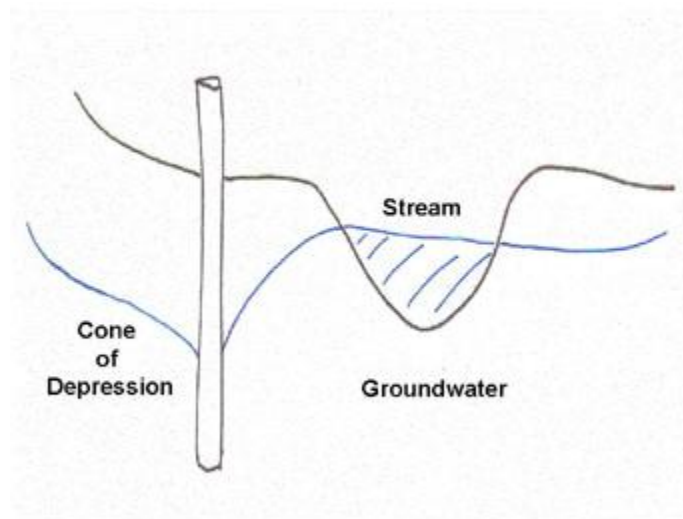
1. The level of groundwater, or water table, is lowered and a cone-shaped depression on the surface of the water table is formed near the well.
2. Water from other areas rushes toward the well to replace the water that is removed. This phenomenon is called recharge and occurs where there is no barrier to water movement.

In most cases, both effects are observed. Initial pumping causes the water table near the well to drop and forms a cone-shaped depression on the surface of the water table (see figure above). As pumping continues and more water is removed, the cone expands, but at an ever-slower rate because the expansion of a large cone of depression requires more water to be withdrawn than a smaller one.

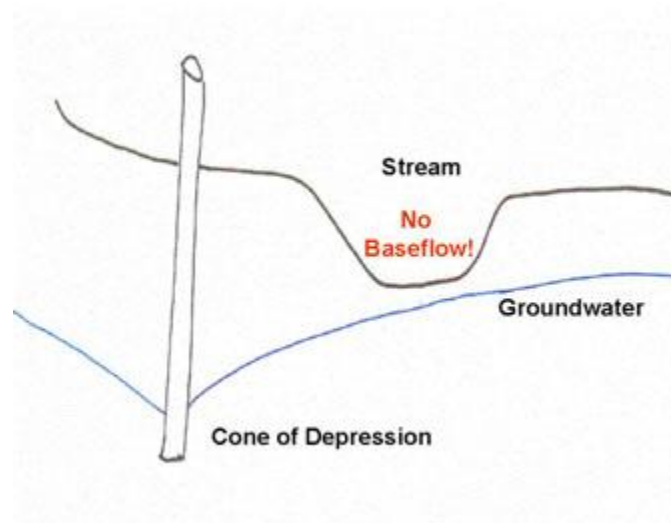
In some cases, as the cone of depression expands, it hits a recharge feature, or another source of water such as a river or lake. Continued pumping of the well may induce infiltration, or cause water to flow from the recharge feature into the ground and slow or halt the expansion of the cone of depression. If the stream is small relative to the amount of water being withdrawn, it may dry completely, especially during periods of naturally low flow (see figure below). If this happens, the cone of depression will extend beyond the recharge feature and continue to expand. On the other hand, if there is an impermeable layer, such as clay, on the lake or river bottom, there may be little interaction between groundwater and surface waters.

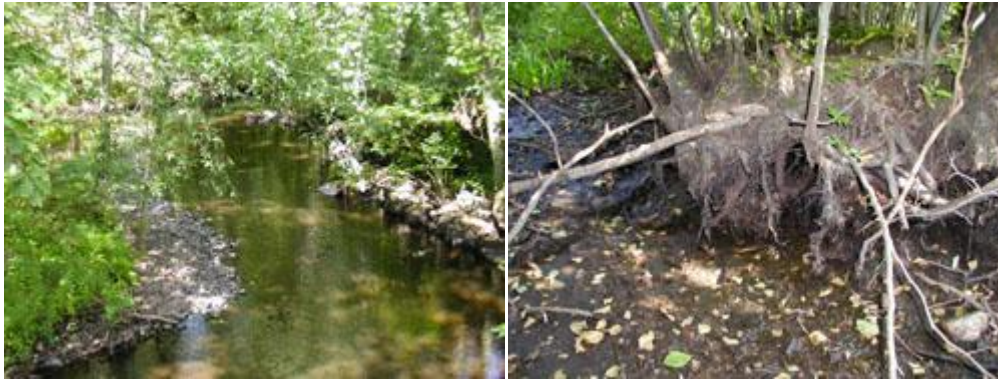
As water levels recede further, riffles may dry out (below left), cutting off migration and movement routes for aquatic species as well as cutting off the flow of the river that some species require to survive or reproduce successfully. Riffles serve as some of the most productive areas for aquatic macroinvertebrates, such as mayflies and stoneflies, which are a major source of food for many fish.

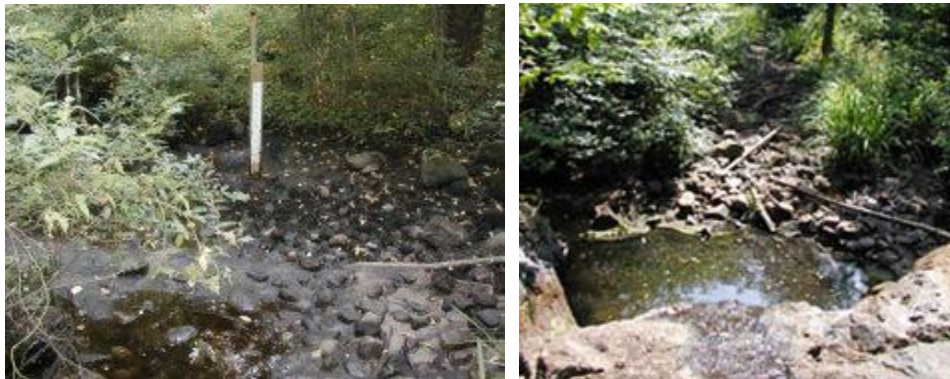
In extreme cases, rivers may dry into a series of isolated pools (below right). Aquatic organisms are then concentrated into small spaces with little cover and increased predation risk.

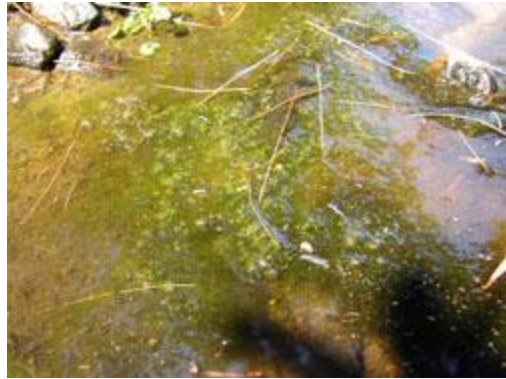
In streams and rivers with large loads of pollutants, low water levels can concentrate these pollutants and cause health concerns for aquatic species and humans alike. Low water levels also concentrate nutrients such as nitrogen and phosphorous which can lead to unpleasant algal blooms in many water bodies, as shown here.

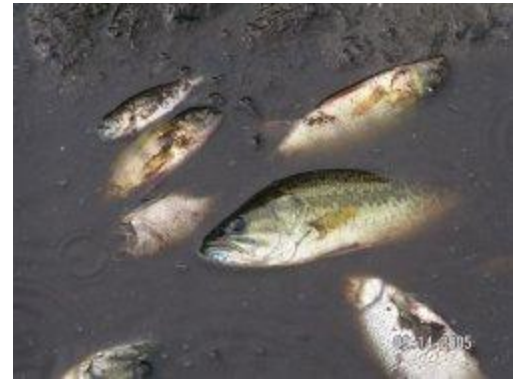
Water that is released over the dam from the surface layers will often raise the temperature of the stream below the dam, which can cause added stress to downstream aquatic life that may depend on cool water temperatures. Water released from the lower layers can actually cause fish (and other organism) kills if it is severely oxygen depleted.

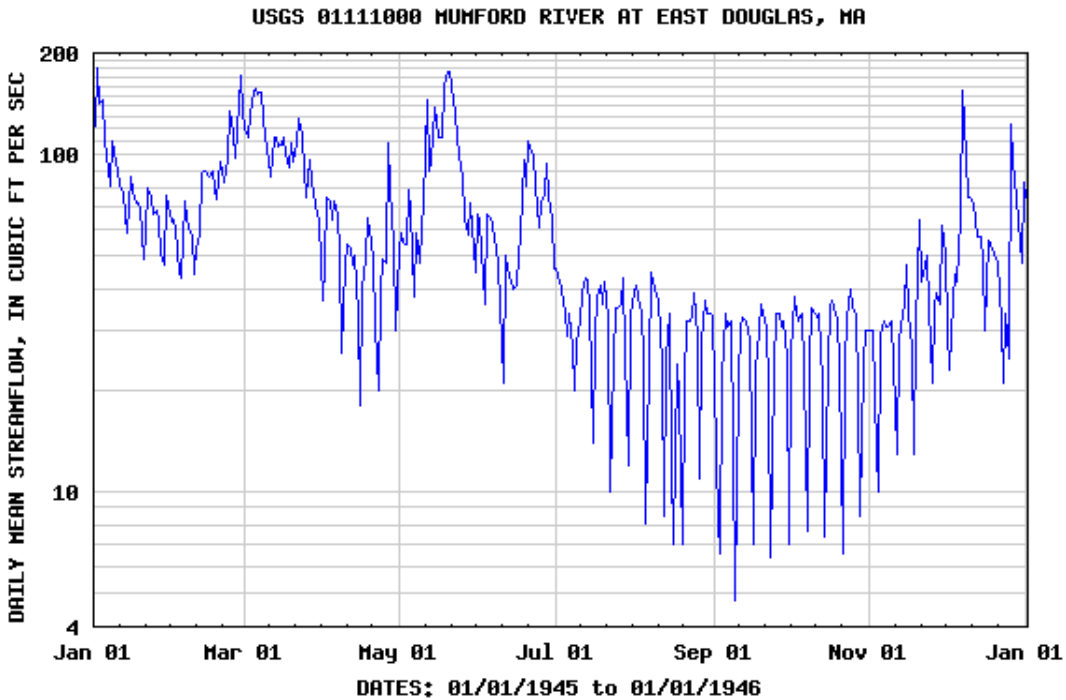
Dams can also cause changes in the rate of water level fluctuation in a river. Some hydropower dams operate in “hydropeaking” mode to provide energy when it is most needed. Water is held behind the dam during hours when energy demand is low and released only when energy demand is high. While this may sound like an intelligent way to provide energy on demand, it means that the river downstream of the dam is exposed to near-dry conditions while water is filling up behind a dam, followed by large surges of water released to produce energy. These fluctuations can occur several times a day below some hydropower dams. The graph below shows the effects of a hydropeaking dam on the Mumford River at East Douglas . Notice how streamflow declined as water was stored behind the dam (falling limb of each peak) and streamflow increased as water was released over the dam to generate power (rising limb of each peak), particularly from July through November.

The flow fluctuations on the Connecticut River at the hydropower dam in Holyoke can be seen at the USGS real-time website for the Holyoke stream gage. Rapid daily fluctuations for power generation, often referred to as "hydropeaking", can cause scour, erosion, and downstream sedimentation problems as well as stranding aquatic organisms from eggs to adults in isolated pools or on dry land.

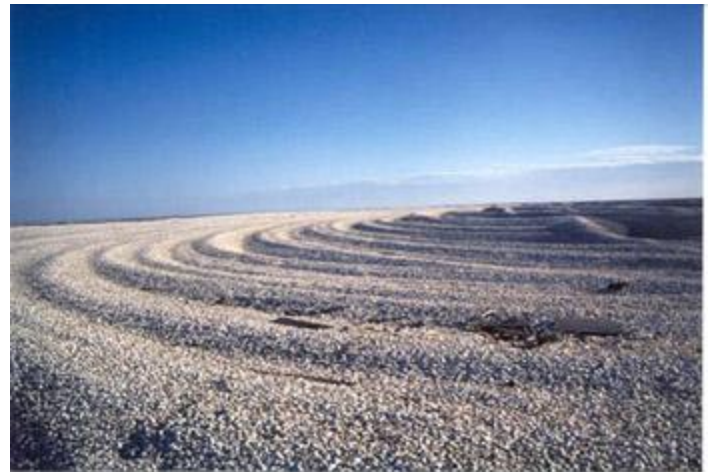
intertidal zones or salt marshes. River flow also controls the depth and temperature of many estuarine habitats. The photo to the right shows islands of clamshells in the Colorado River Delta, illustrating the 90% decline in clam abundance due to the lack of fresh water flow from the Colorado River.
